MEMORANDUM

Date: 9 May 2013
To: P. Barrett – FDEP NRDA Project Coordinator
Cc: T. Day – Escambia County, FL
From: Albert E. Browder, Ph.D., P.E.
Senior Engineer *ABE*
Re: Six-Month Warranty Period Site Visit – 6/7 May 2013

olsen
associates, inc.
Coastal Engineering

Pensacola Beach, FL, Dune Restoration Project

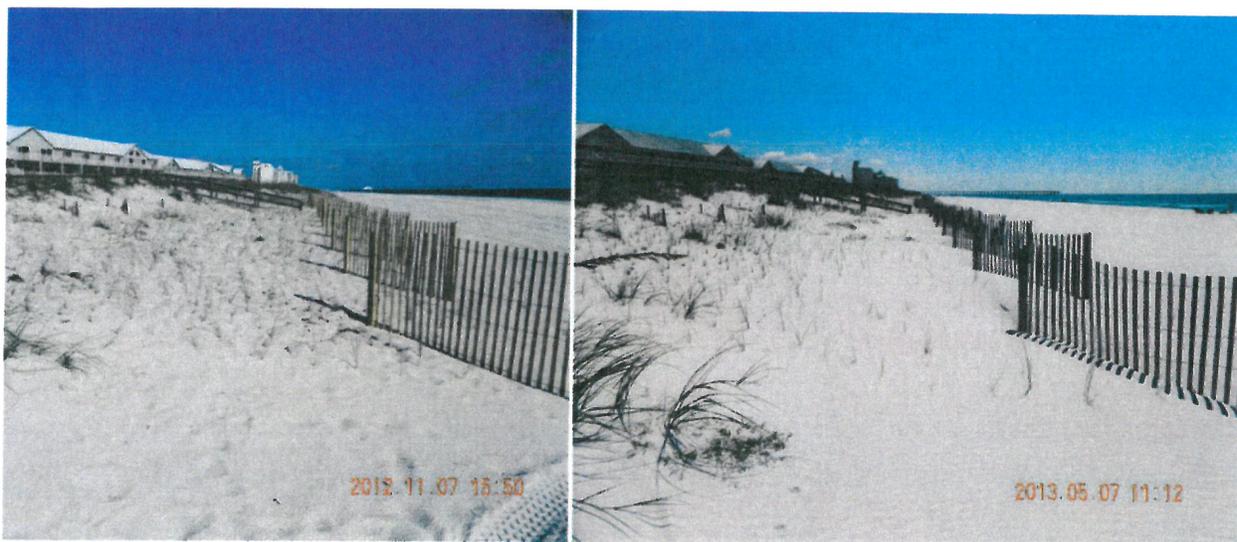
1) The project work area (e.g. the sand fencing) has experienced a significant volume of wind-blown sand accretion over the first six months of the project life. This period from November 2012 through April 2013 was dominated by strong winter weather. **Figures 1-3** illustrate the deposition of sand between and landward of the sand fencing sections. In general, deposition along the fence sections ranged from 4 to 6 inches of accretion, while the mounds of

sand between sections gained as much as 12 inches or more during this period. The accretion extends in waves landward of the fencing for 10 to 15 ft. The accretion likewise appears to extend along the entire length of the project (local exceptions noted below). A very rough estimate of the volume of accretion might conservatively be on the order of 10,000 to 15,000 cubic yards of sand accumulated¹.

Figure 1 Dune restoration project conditions at installation (0 months – November 2012) and at six months (May 2013) in the vicinity of R-116 and the White Sands Condominium. Note the significant deposition of sand in the vicinity of the sand fencing sections. The deposition has buried a noticeable fraction of the plants, however, inspection of the buried plants indicates continued survival and growth.

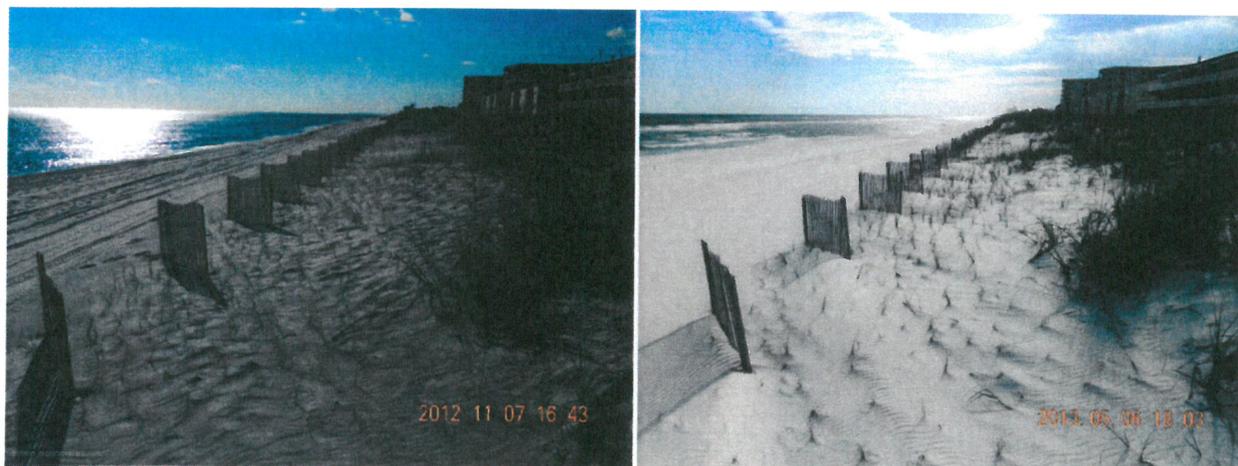
Figure 2 Dune restoration project conditions at installation (0 months – November 2012) and at six months (May 2013) in the vicinity of R-136 at Calle Bonita. Note the significant deposition of sand in the vicinity of the sand fencing sections.

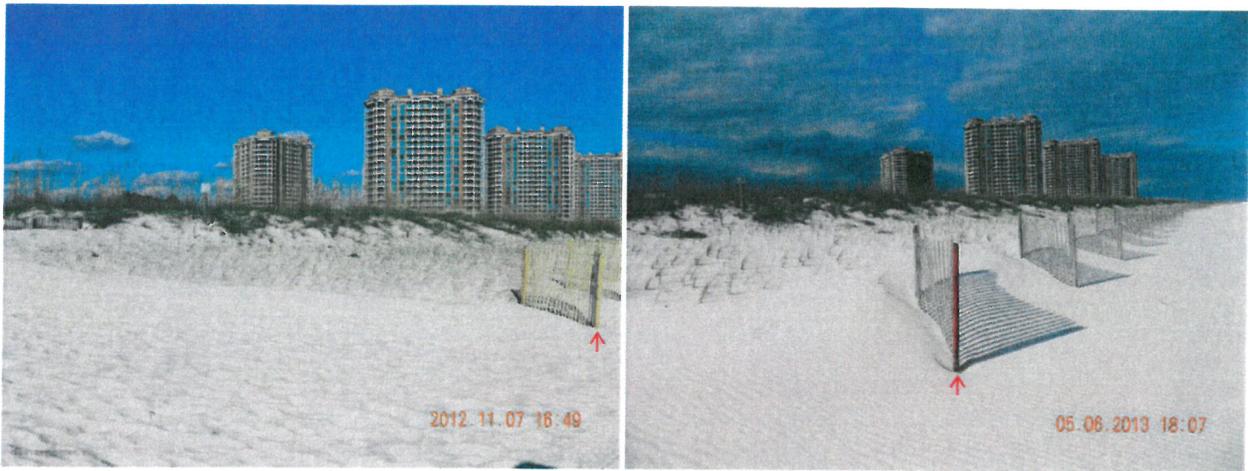
Figure 3 Dune restoration project conditions at installation (0 months – November 2012) and at six months (May 2013) in the vicinity of R-140, just west of Portofino.

3) Another factor in the growth of the plants appears to be the positioning of the sand fencing relative to the planting zone. The base design of the installation called for the placement of the sand fencing to lie Gulfward of the plants (e.g. **Figure 3**). Due to local concerns over excessive encroachment of the installation upon the recreational beach space, the sand fencing was shifted landward to different degrees, principally along the western portions of the project. At the six-month mark, the plants installed landward of the sand fencing appear to have experienced improved growth, while plants installed Gulfward of the fencing appear to be more stressed (**Figures 4 and 5**). Survivability of the plants installed Gulfward of the sand fence is very high, but growth has been limited. This condition is expected to improve in the subsequent six month warm period.

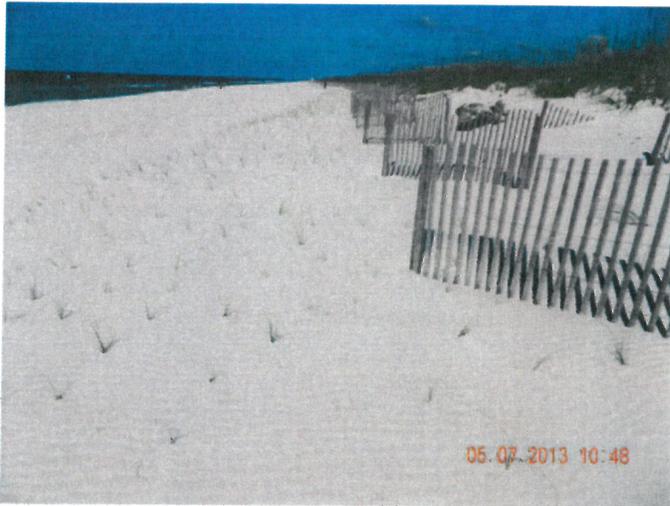
Figure 4 Shoreline conditions near R-109 at Park West, in the vicinity of the newly established dog park (background). Here the sand fencing was installed closer to the existing dunes and the plants Gulfward of the fencing appear more stressed. Survivability did not appear to be significantly reduced but plant growth is more limited.

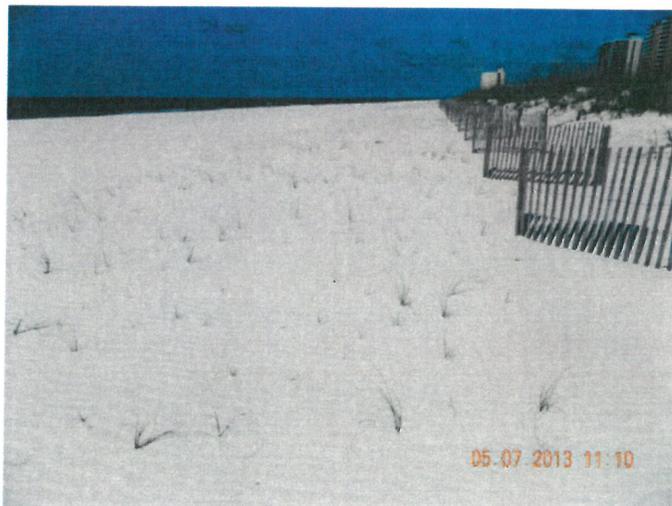
Figure 5 Shoreline conditions near R-115 at the Cross. Here the sand fencing was installed closer to the existing dunes, with a wide planting zone Gulfward of the fencing. Plants in this zone appear more stressed and growth is limited. Survivability did not appear to be significantly reduced but plant growth is more limited.

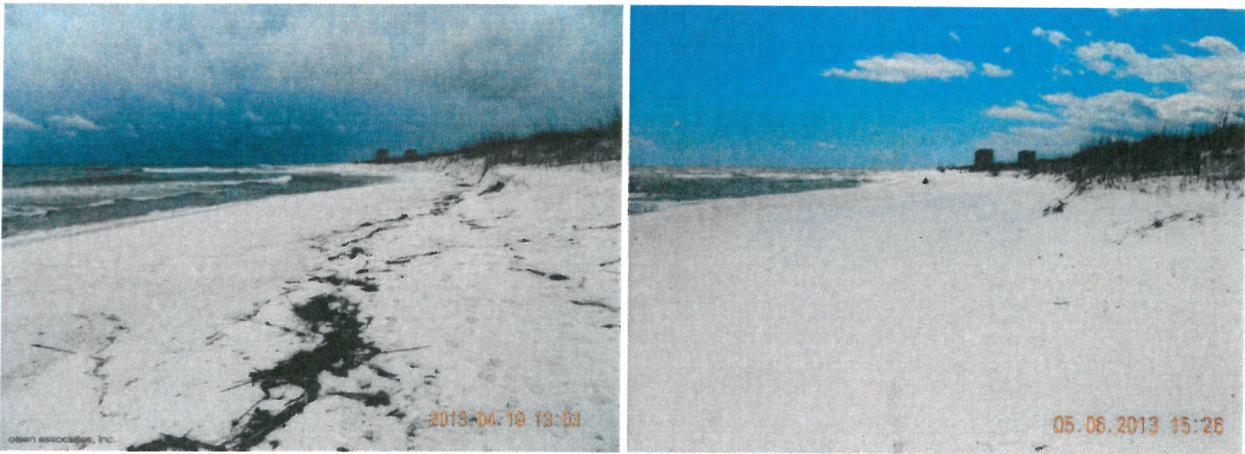
Figure 6 depicts such a feature that developed just east of the parking lots at Park East near FDEP monument R-149.5. In this area the entire installation was lost along a 200-ft segment of the beach. At the time of the May 2013 site inspection, the area had recovered due to a significant shift in wave conditions from easterly to westerly. As shown in Figure 5, the area had been significantly impacted as recently as three weeks prior (probably even more recently). Despite the loss, the presence of the installation likely protected the pre-existing engineered dune from further damage. **Figure 7** depicts a similar, but less severe condition just west of Parking Lot F (R-146.5), in which the sand fencing and Gulfward half of the dune restoration was lost for a distance of roughly 200 ft. Overall, these areas represent roughly 1.0 to 1.5% of the total project.

Figure 6 Impacts of beach cusp activity east of Park East (R-149.5). Note the distinct embayment of the cusp in the left frame and the narrow beach conditions, which eroded the installation away and left a localized dune scarp in the engineered dunes. Three weeks later (right frame), the wave conditions had shifted significantly and the beach had widened by roughly 100 ft.

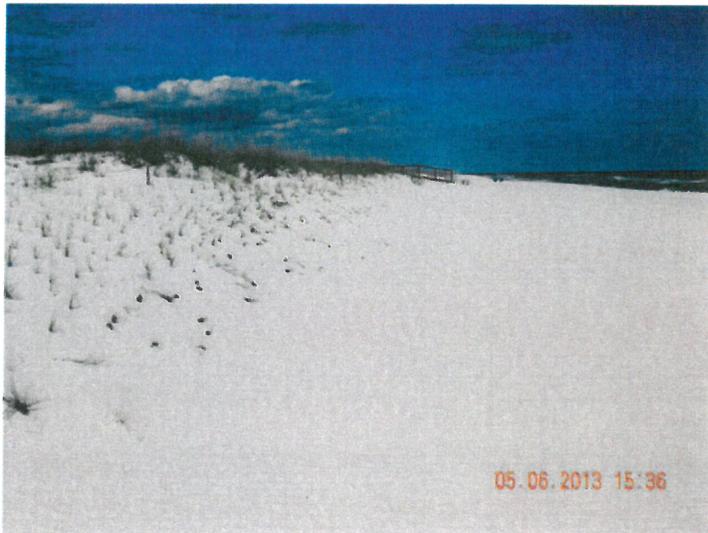
Figure 7 Dune restoration conditions just west of Parking Lot F near Park East, indicating the loss of the sand fencing and a portion of the plantings in this roughly 200-ft segment. The segment had been impacted by beach cusp activity over the winter.

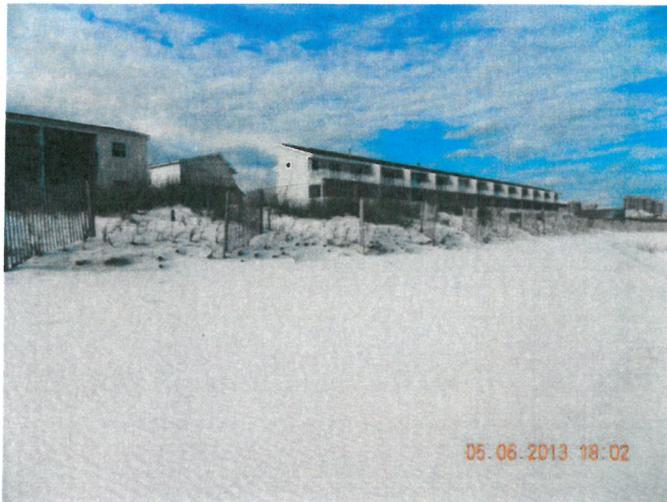
5) Other areas of the project experienced similar, but less severe, erosion and loss of the Gulfward edge of the planting zone. Most notably, the area between Regency Towers and Calle Bonita (R-135.5 to R-136, **Figure 8**) appears to have experienced plant loss along the Gulfward edge. It is noted that in this area a transition occurred in the sand fencing location, moving the fence sections landward and exposing the plants to a higher level of stress and erosion. It is unknown whether the sand fencing would have survived the wave impacts as the cusp passed this area. Immediately east of the cusp-affected area, the fencing was installed on the Gulfward edge, and no losses were noted (**Figure 9**).

Figure 8 Loss of plants installed seaward of the sand fencing near Calle Bonita (R-135_5). It is opined that the losses are attributable to beach cusp activity, note the scarp remnant on the right edge of photo. It is further noted, however, that the sand fencing was installed in a landward position, with the plants installed Gulfward of the fencing.

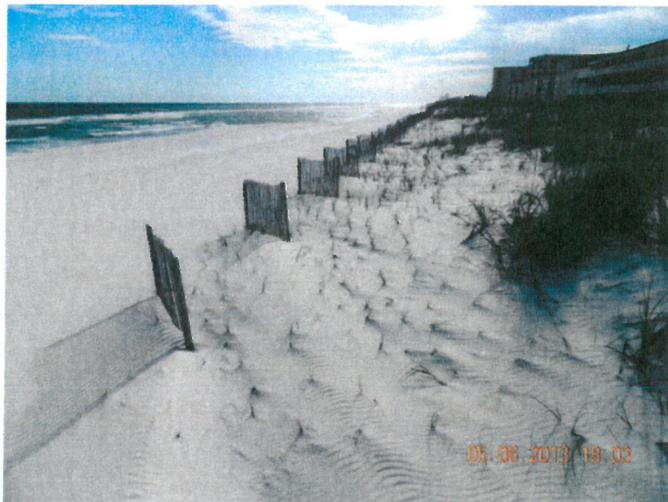
Figure 9 Dune restoration conditions at Calle Traviesa, immediately east of the area shown in Figure 7. Note the accretion in the project area.

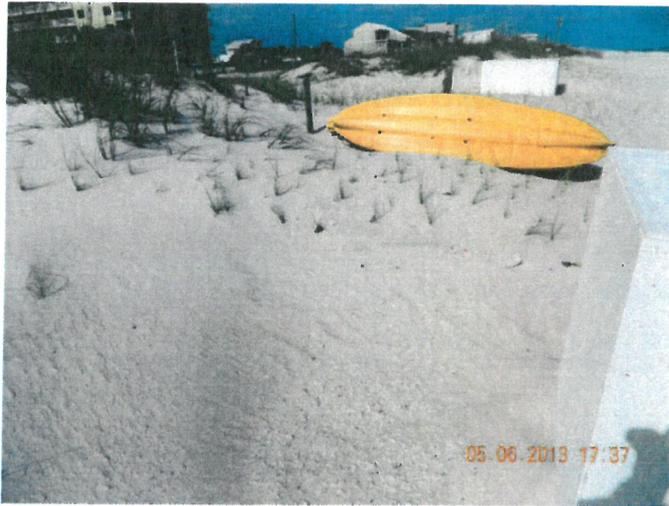
6) Within the highest-traffic hotel zone, a variety of installation patterns were implemented, depending on the input of the individual property owners. Many areas in the commercial core east of Casino Beach were planted without the protective benefit of sand fencing (to avoid encroachment on recreational space). A combination of the foot traffic, the concessionaire equipment, and the lack of fencing resulted in some small localized areas of plant loss (**Figure 10**). In areas that were undisturbed, however, plant survivability was high, but overall growth was limited (**Figure 11**). This may be a result of the winter weather of the first six months of the project life. As an example, the area fronting the Hampton Inn appears to have high survivability, but the plants appear to have limited growth. This area was noted in November 2012 as an area of concern, and bears continued attention. The sand fencing installed in the area does appear to be effective in preventing significant foot traffic damage.

Figure 10 Localized wind scour and damage to plantings due to concessionaire equipment placement (R-123.5).

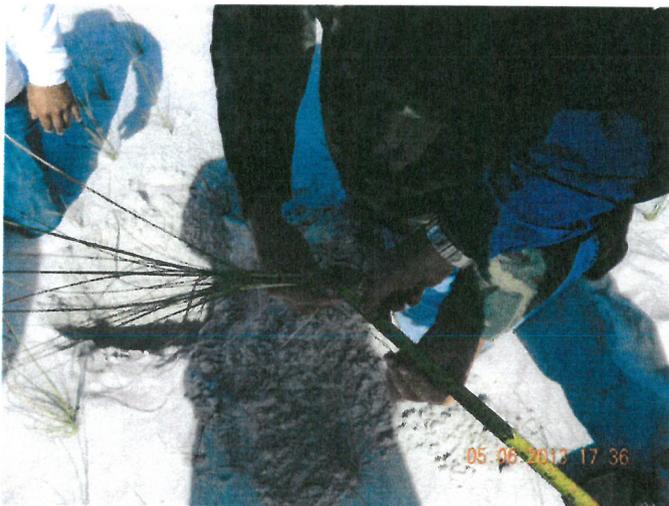
Figure 11 Measuring plant root growth near R-123.5 in the hotel zone at Pensacola Beach, FL.

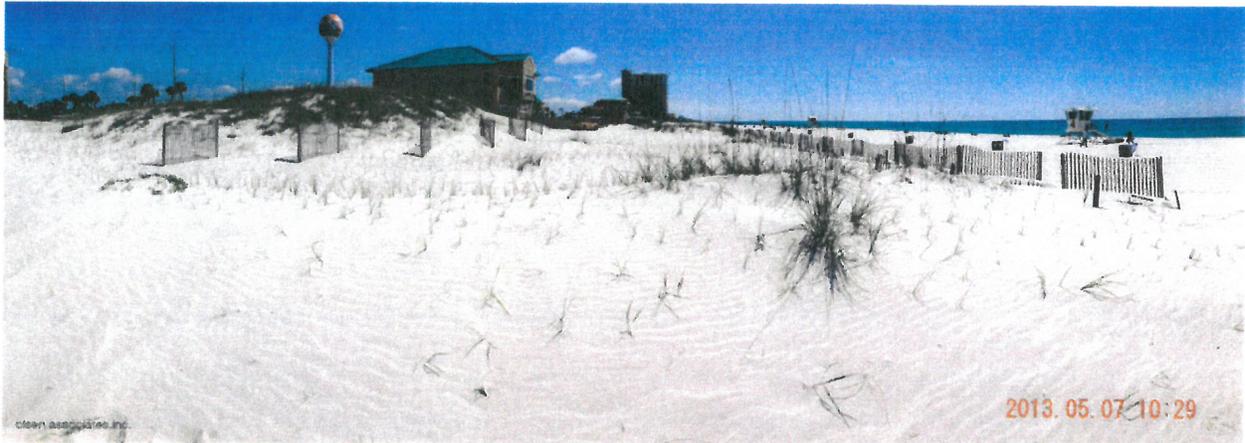
7) Similarly, at the fishing pier and at Park West the high-traffic areas produced some plant loss along the pathways leading to the beach. Elsewhere in these replanting areas, plant survivability appears to be high, but again growth is somewhat limited (**Figures 12 and 13**). These areas also experienced noticeable accretion.

Figure 12 Dune restoration/replanting area between the fishing pier and the public safety building at Pensacola Beach. Note the wind-blown accretion across the area.

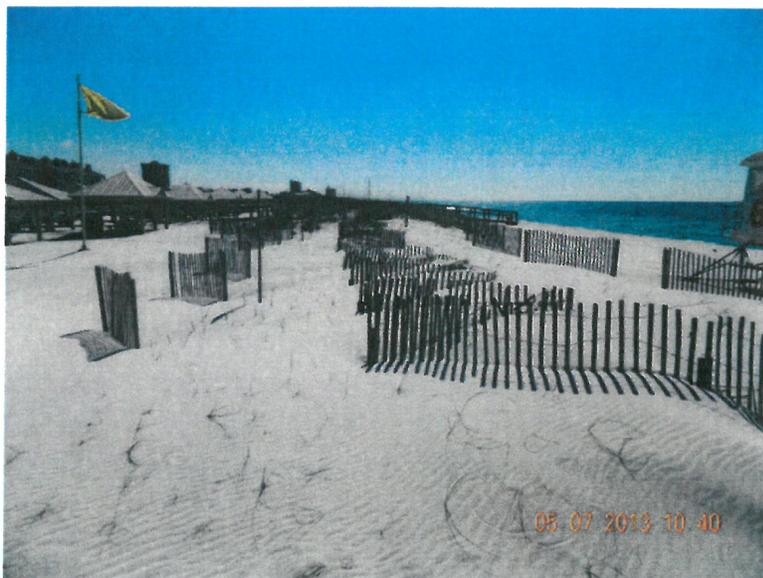
Figure 13 Dune replanting area at Park West (Ft. Pickens Gate Park). Some minor foot-traffic damage and loss of plantings was noted along the travel pathways.

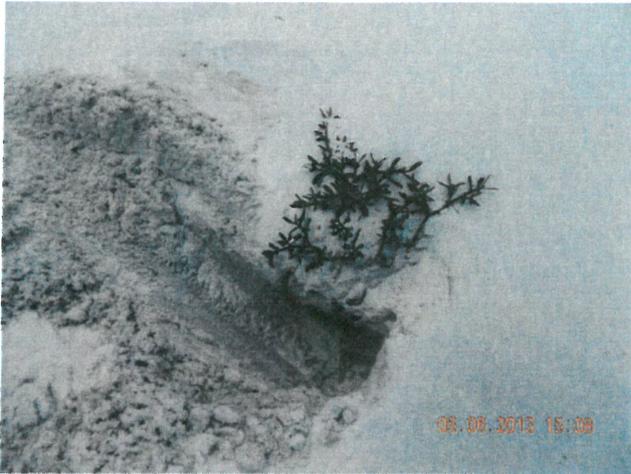
Figure 17 Growth of sea purslane plant unit in depositional area near park East (R-150).

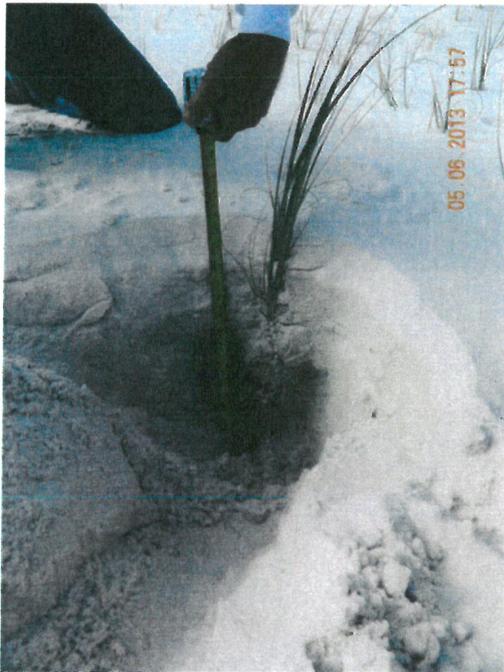
Figure 18 Sand burial and growth of plant unit in depositional area near Avenida 23 (R-135).
