Dune Restoration, sand fence and sign installation

USFWS F12PS00641

Wetland Sciences is providing a summary of efforts and services associated with the completion of the dune restoration project in Alabama as associated with the United States Fish and Wildlife (USFWS) solicitation F12PS00641. The following products and services were provided by Wetland Sciences (WSI) and the White Sands Planting Company (WSPC).

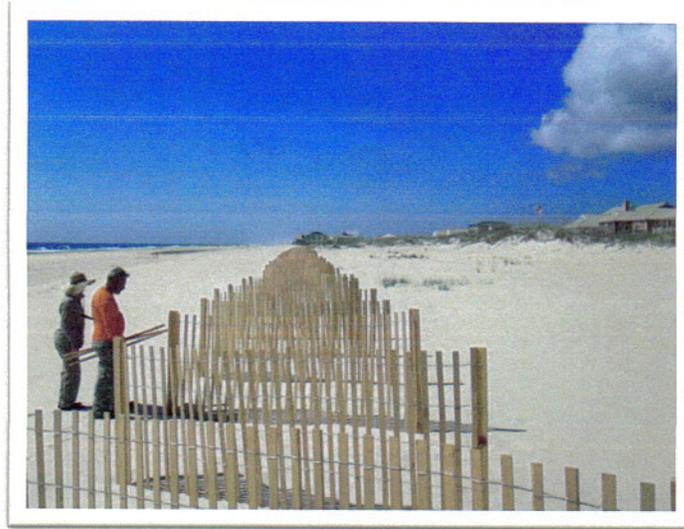
Typical sand fence configuration. Photo taken West of Our Rd. within BLM property. Faye Winters and Robby McKee inspecting

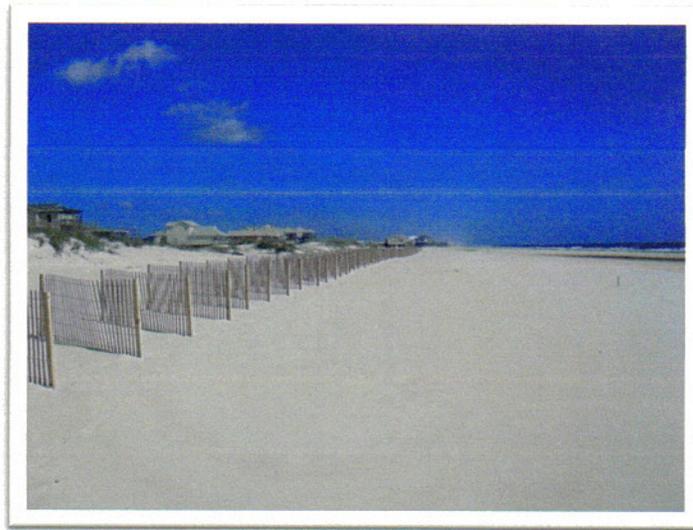
View East along an extensive sand fence run in Gulf shores Alabama

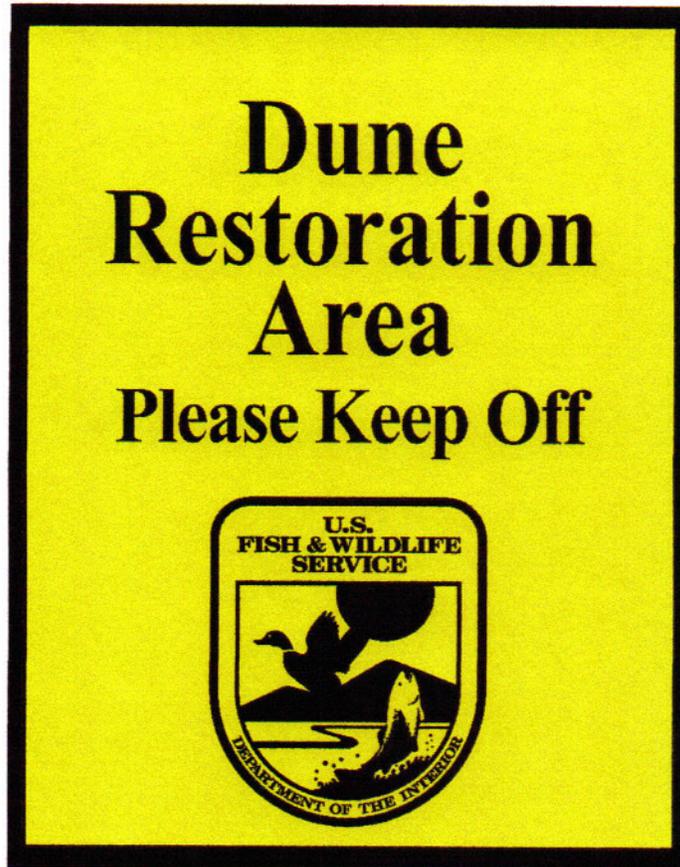
Example of the USFWS 11x14 signs that are installed within the Bon Secour National Wildlife portion of the Project

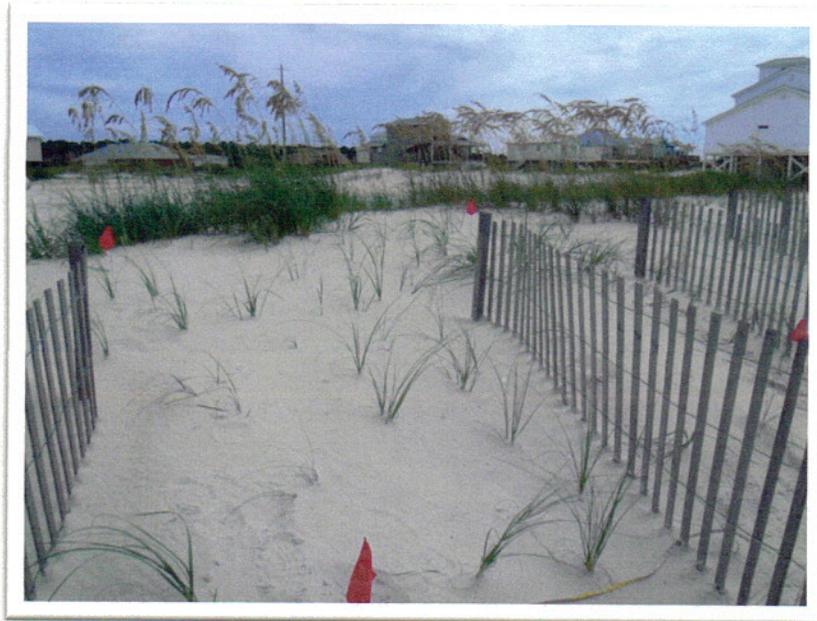
Red flags represent the survivorship evaluation plots

Survivorship reviews were accomplished within a 90 day and 180 day post planting as referenced in the contract, these plant condition review efforts consisted of the COR and planting contractor meeting during the time frames specified from the date of the initiation of planting. When the random planted area was chosen a subplot (10x10) was established and surviving plants were counted, condition noted, and deficiencies discussed.

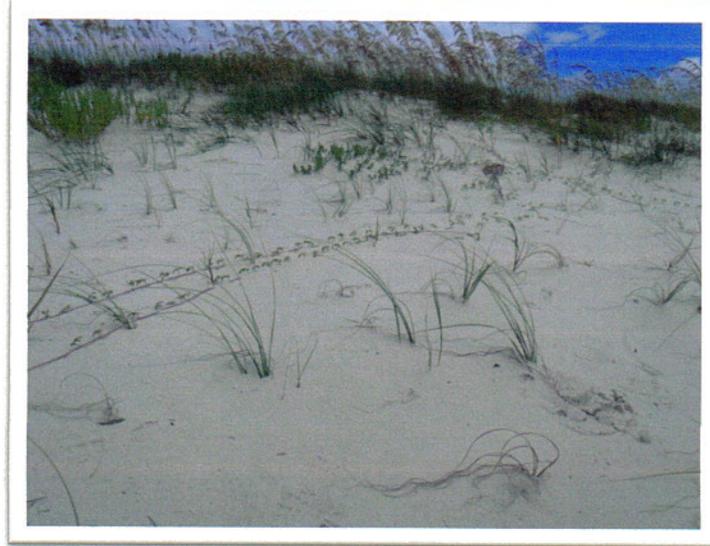
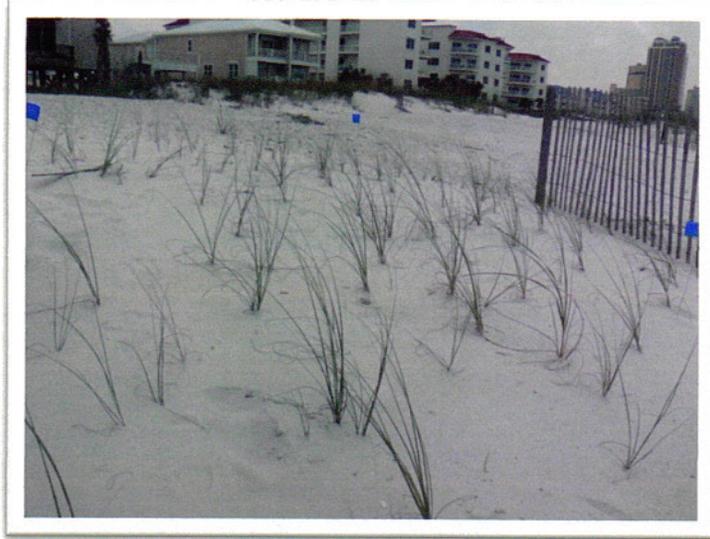
Representative Condition of planting site 180 days after installation. These plants should continue to produce vegetatively and produce seed heads at the end of next growing season (2015).

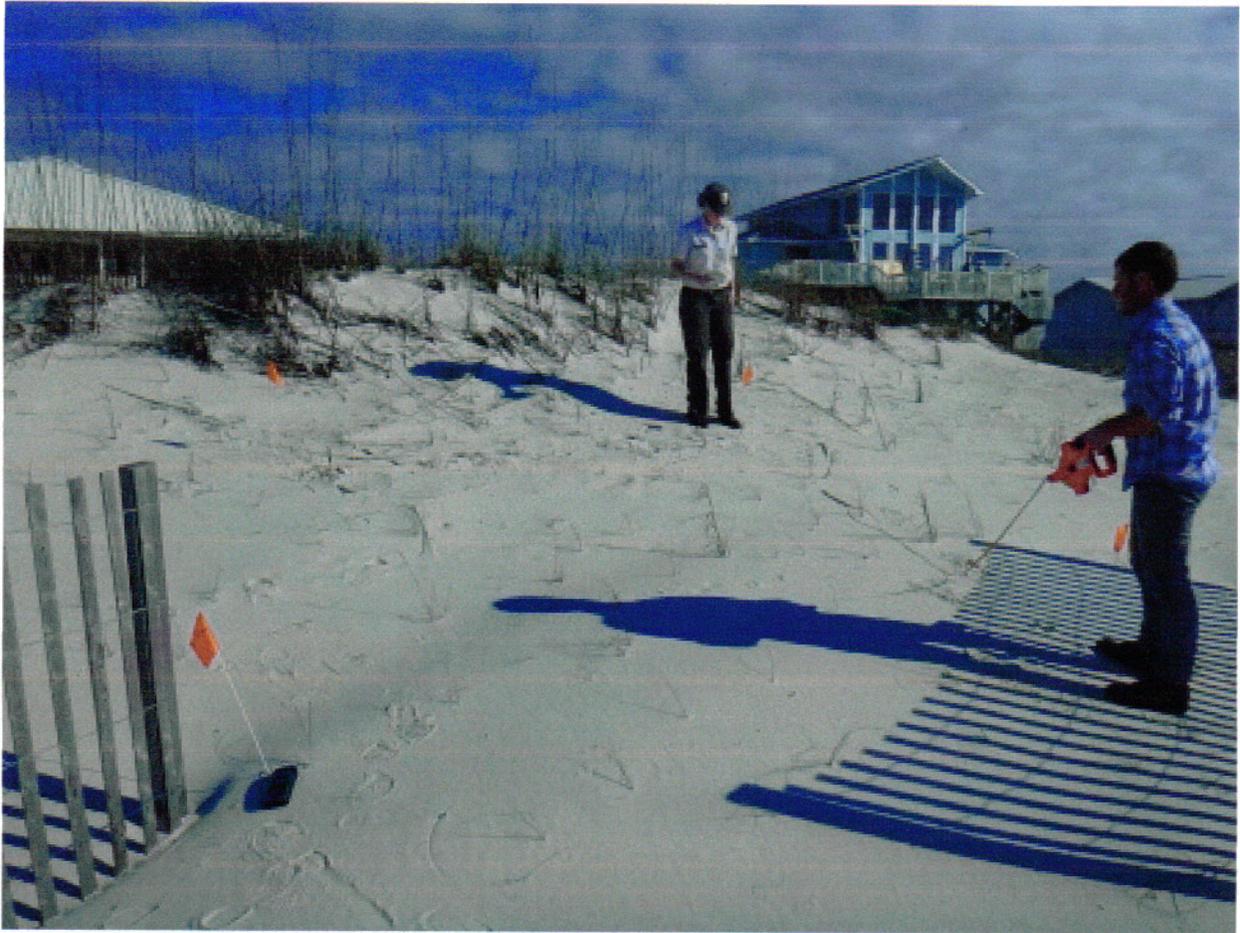
March 19, 2014 Survivorship review

WP (13) 429987 3345815
photo 100-0031
28 plants
Sea oats and Patens
Spring break area plants trampled

WP (14) 0430800 3345917
photo 100-0032
25 plants
Sea oats
fences down, Spring Break area

Fence down

COB (3)
WP (22) 449333 3349807
photo 100-0042
53 plants
Sea oats patens
* near this 12-16 fence
(plants w/in burn out)

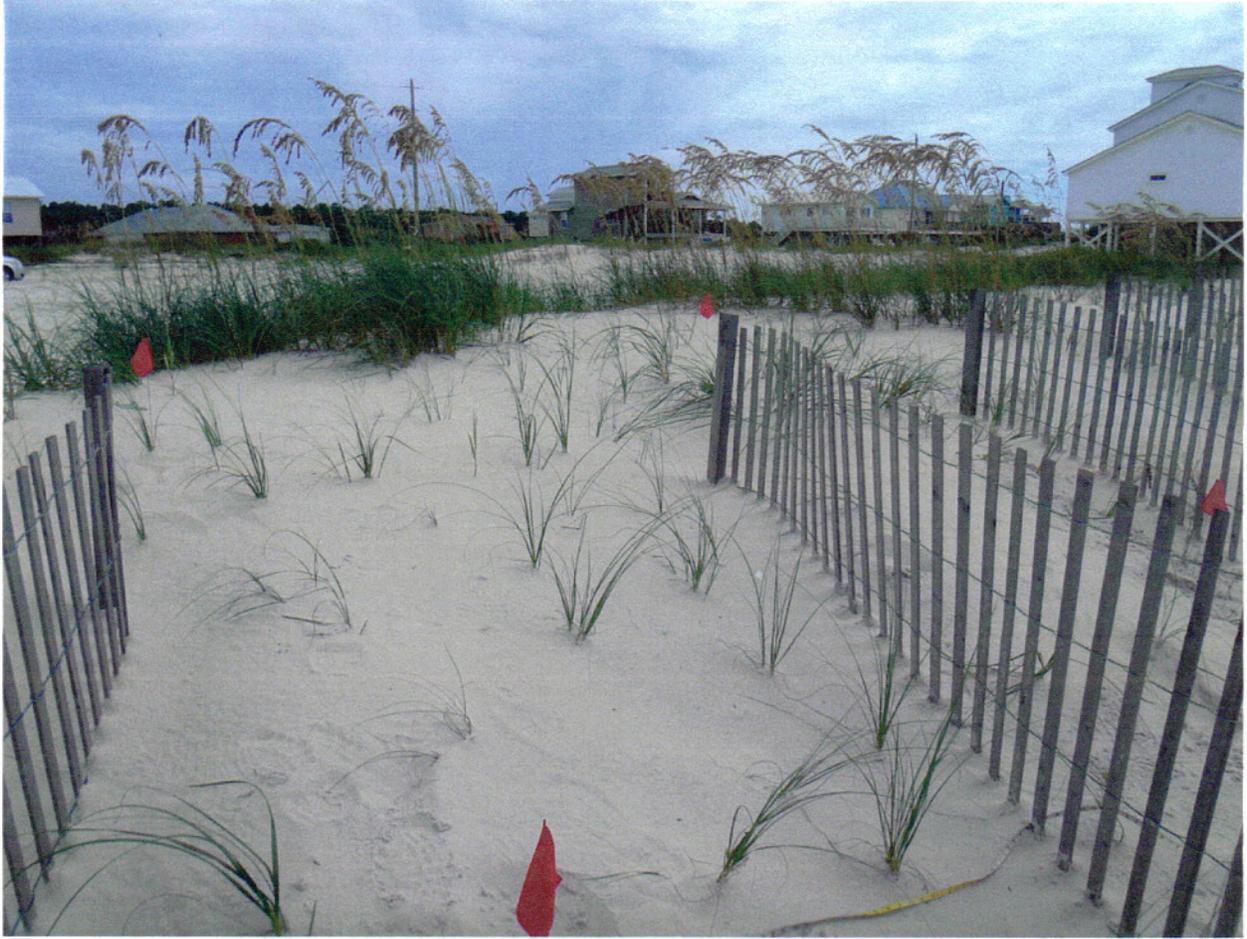
August 21, 2014 Review

55 plants in 10x10

~80%

plants - 0 (washed out)

still washout death

dunes growing because of
sand fence - ~~oats~~ covering plants
faster than they can grow

Slight
erosion
in
the
area

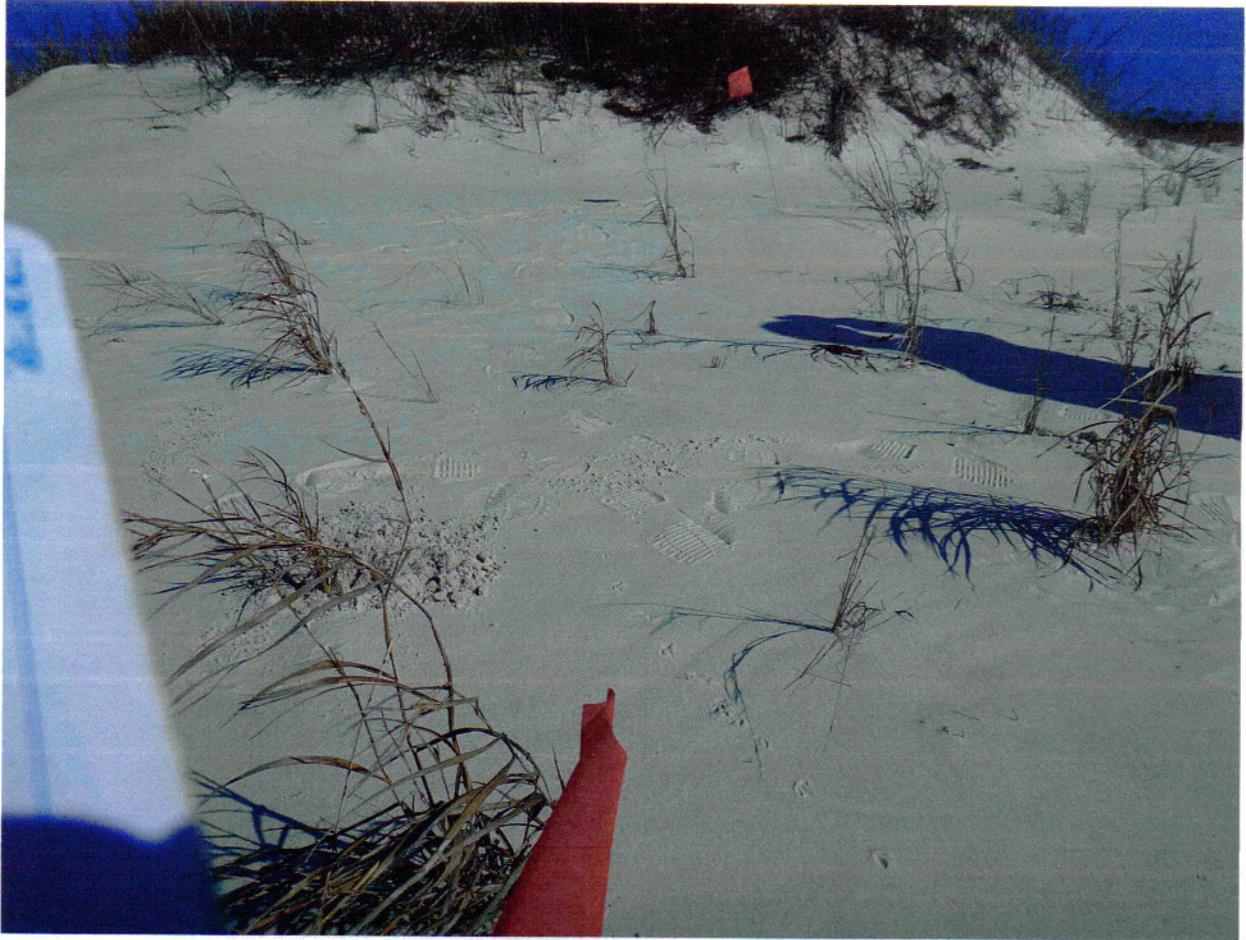
December 19, 2014 Survivorship Representative Photographs

plants - 0 (washed out)

still without death

FM BSNWR Mile 2-1
photo 100-0010
plants - 42
still some washout
oats, panic, patens

dunes growing because of
sand fence - ~~oats~~ covering plants
faster than they can grow
